Report:
Hotel Facility

Thermographer:
Building Diagnostics Group

Equipment Room F

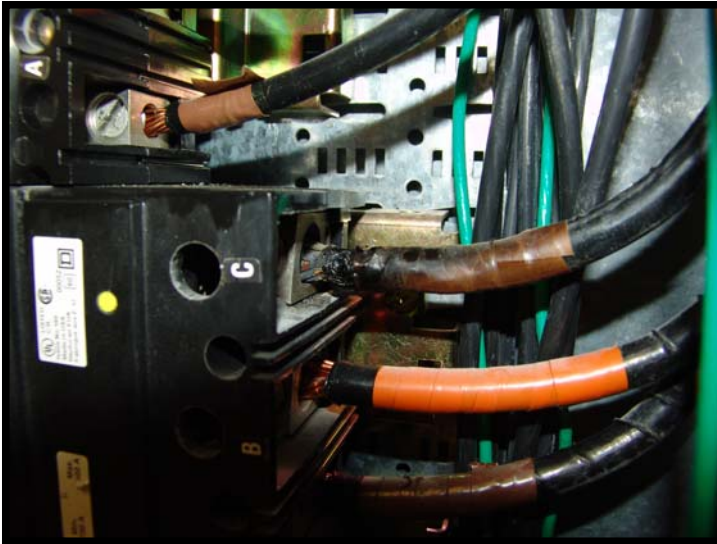
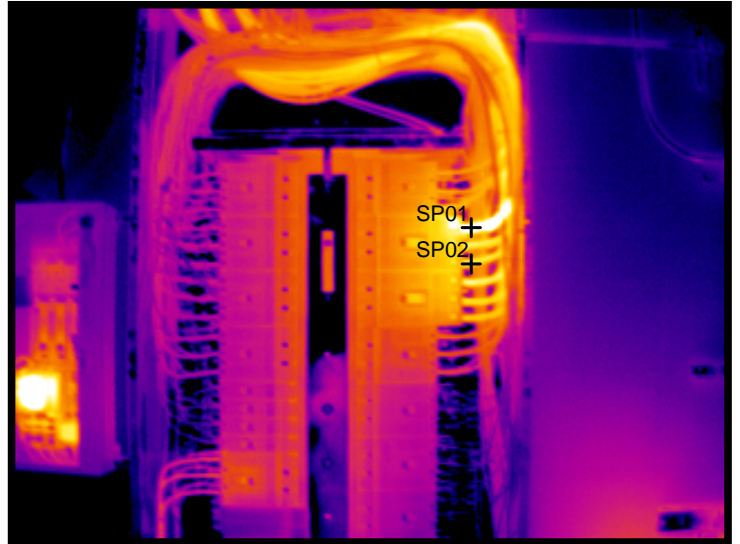
IR information	Value
File name	lr_0310.jpg
Camera serial number	25300633
Camera lens	45
IR Text Comment	Value
Location	Equipment Room F
Sub location	Panel AD-5
Fault	B
Label	Value
IR : max	162.5°F
SP01	162.1°F
SP02	108.3°F

Potential Problem

Action Code Correct prior to next maintenance period.
B
